UST PHOTOGRAPHIC LOG

Facility Location: Sac & Fox Truck Stop, 1346 HWY 75, Powhattan, Kan.		Photographer: Michael L. Pomes	Camera: Canon Powershot SD 1300 IS, #092064146322
Dates Photographs Were Taken: 9/26/2013

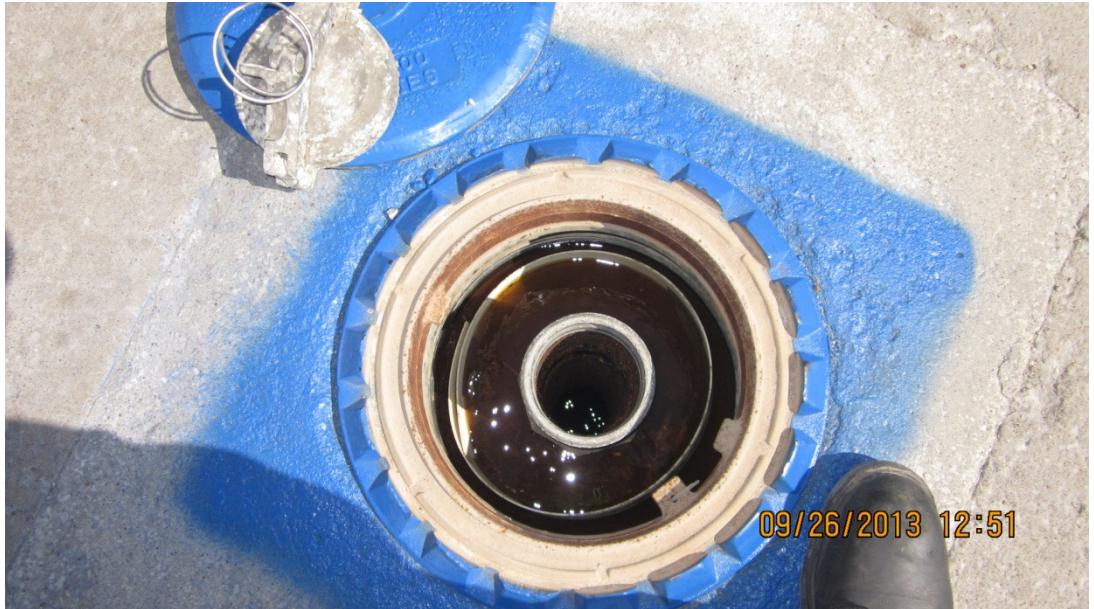
Photographer: Michael L. Pomes	
Photo No. 7	Time: 1251
Direction Photo Taken: Down	
Photo Description: North Midgrade (Tank 3) spill bucket with water. Tank fill has no drop tube.

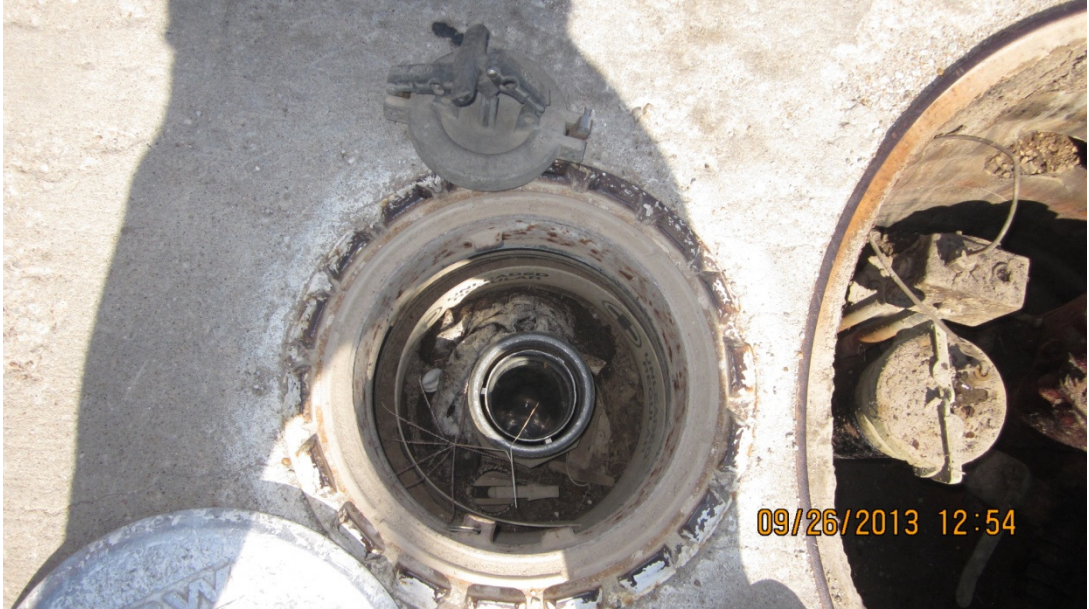
Photo No. 8	Time: 1253
Direction Photo Taken: Down	
Photo Description: Regular unleaded (Tank 2) submersible pump sump and ATG probe. Red Jacket FX1V MLD used for pressure lines leak detection.

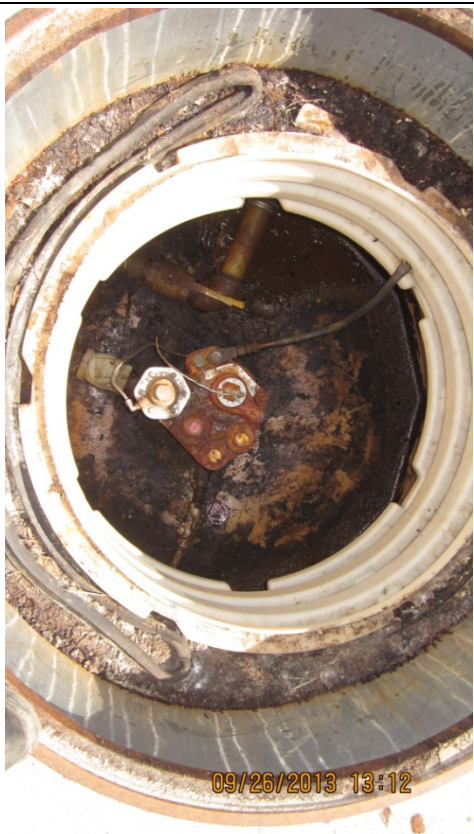
Photo No. 17	Time: 1312	
Direction Photo Taken: Down		
Photo Description: South Midgrade (Tank 5) submersible pump sump. Veeder Root FX1V MLD used for pressure lines leak detection. The sump is contained.

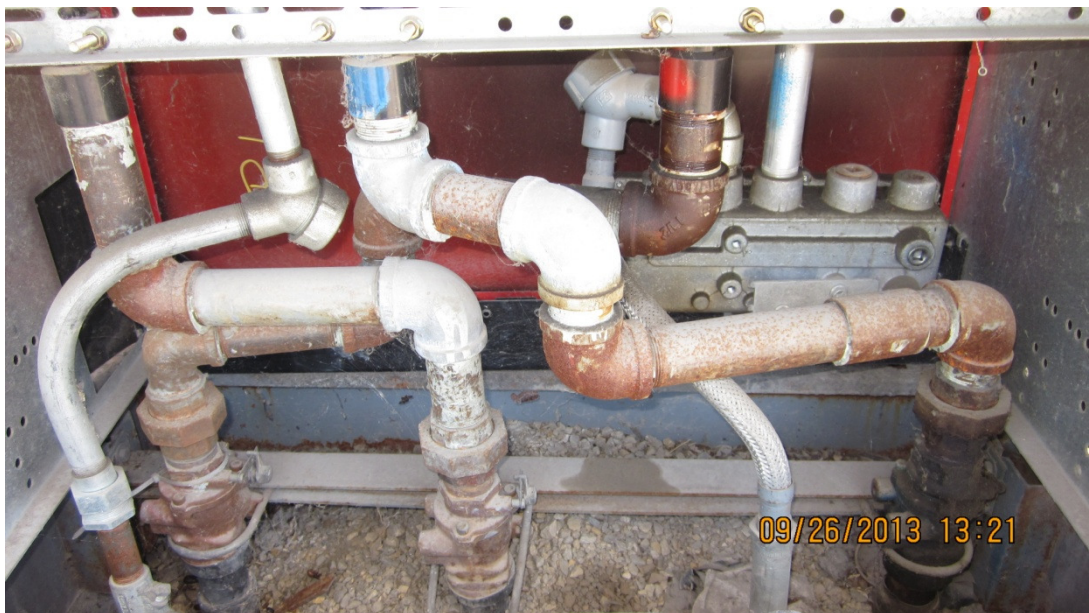
Photographer: Michael L. Pomes	
Photo No. 19	Time: 1321
Direction Photo Taken: Inside	
Photo Description: Wet premium piping inside cabinet of Dispenser 5/6. Flex connectors are booted.

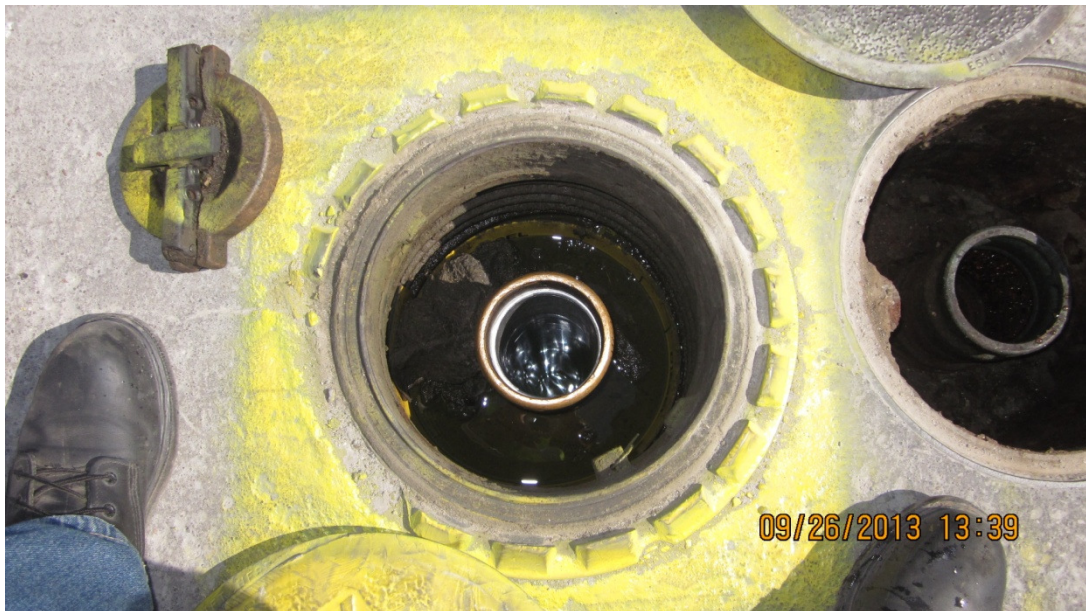
Photographer: Michael L. Pomes	
Photo No. 21	Time: 1339
Direction Photo Taken: Down	
Photo Description: West Diesel (Tank 4) spill bucket with debris and liquid. Tank fill riser has a drop tube.

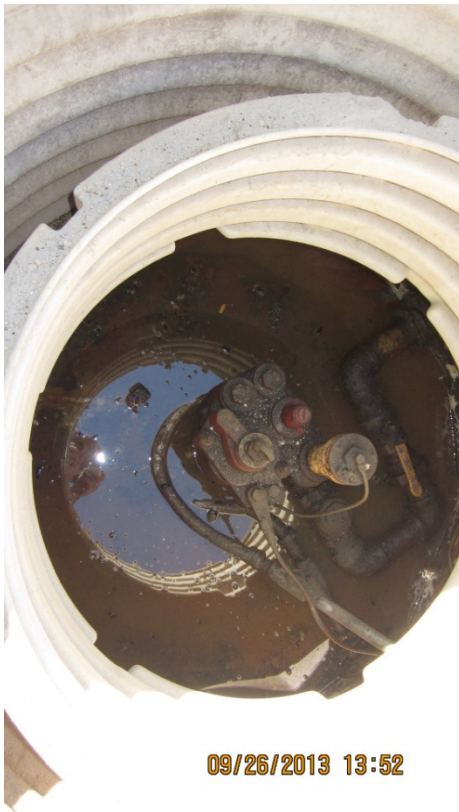
Photographer: Michael L. Pomes	
Photo No. 25	Time: 1352
Direction Photo Taken: Down	
Photo Description: East Diesel (Tank 6) submersible pump sump filled with liquid at the bottom. FE Petro MLD used for pressure lines leak detection.

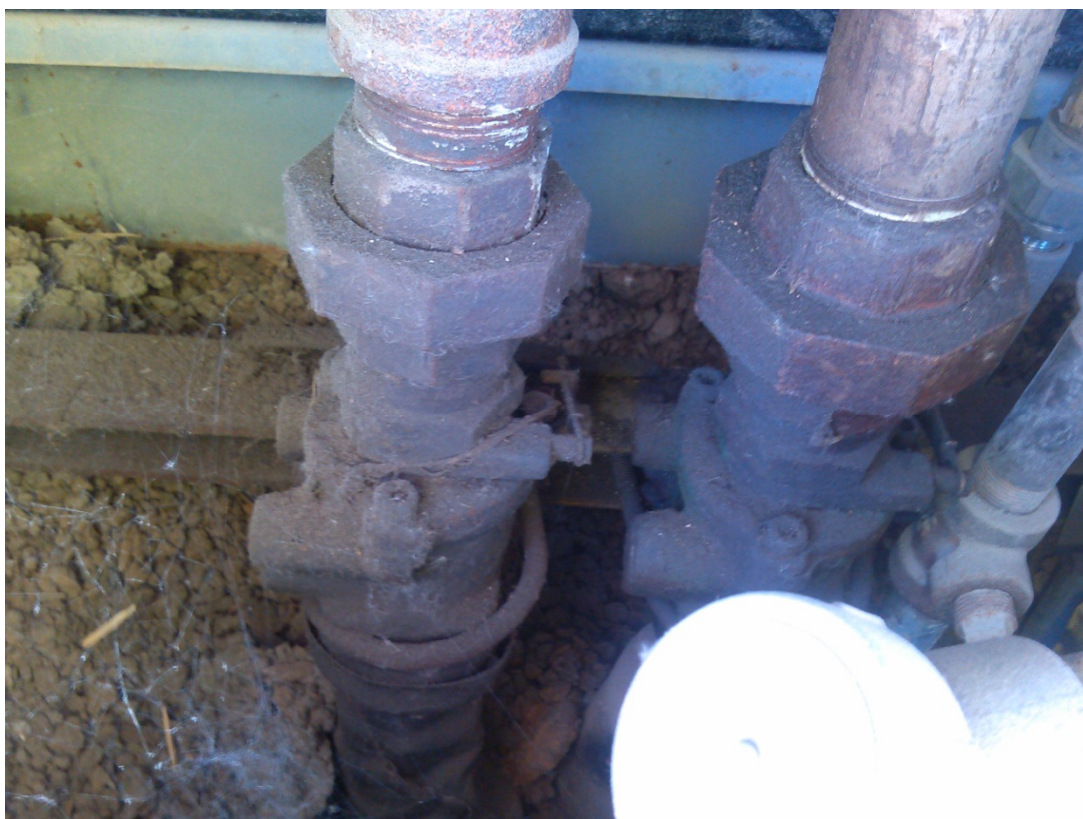
Photo No. 29	Time: 1408
------------------------	----------------------

Diesel Dispenser #2
and slave for Dispenser
#1. Flex connectors
are booted. Photo
taken with Pomes' T
Mobile myTouch Q cell
phone.
